COLORADO CULTURAL RESOURCES INVENTORY

Greeley 8th Avenue Survey

Historical and Architectural Reconnaissance Form

1. Current Property Name: **Reedesign Concepts**
Historic Property Name **Parr Auto Parts**
2. Resource Classification: **Building**
3. Ownership: **Private**
Owner(s) contact info:

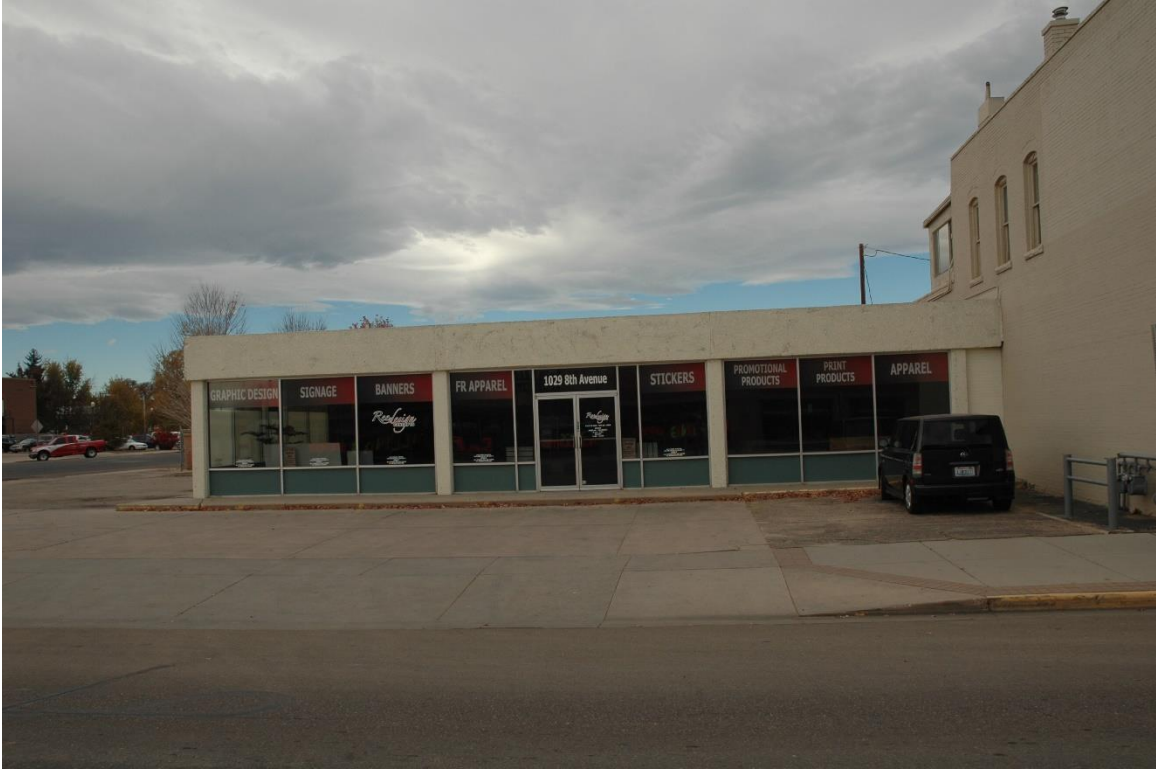
Windows: The symmetrically arranged façade contains eight large single-light fixed-pane display windows in silver metal frames. These windows flank the front entry doors (four on either side) and feature teal color kick plates. Four similar windows flank the entry door on the building's south-facing side.

Porch(s) / Doors: A set of paired glass-in-silver-metal-frame doors, with a transom light and sidelights, enters the center of the symmetrical façade which faces 8th Avenue to the east. A single glass-in-silver-metal-frame door, with a transom light and sidelight, enters the south-facing wall.

CD 1, Image 10, View to west of façade (east)

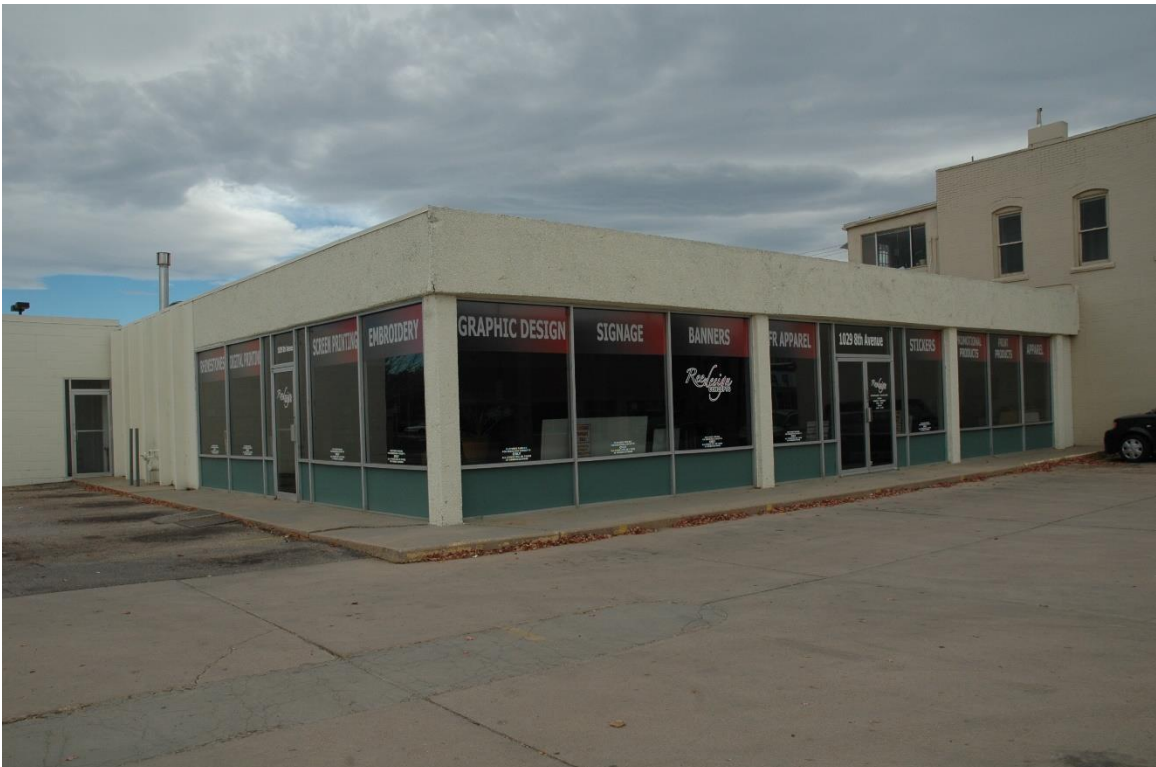
CD 1, Image 11, View to NW of façade (east) and south side

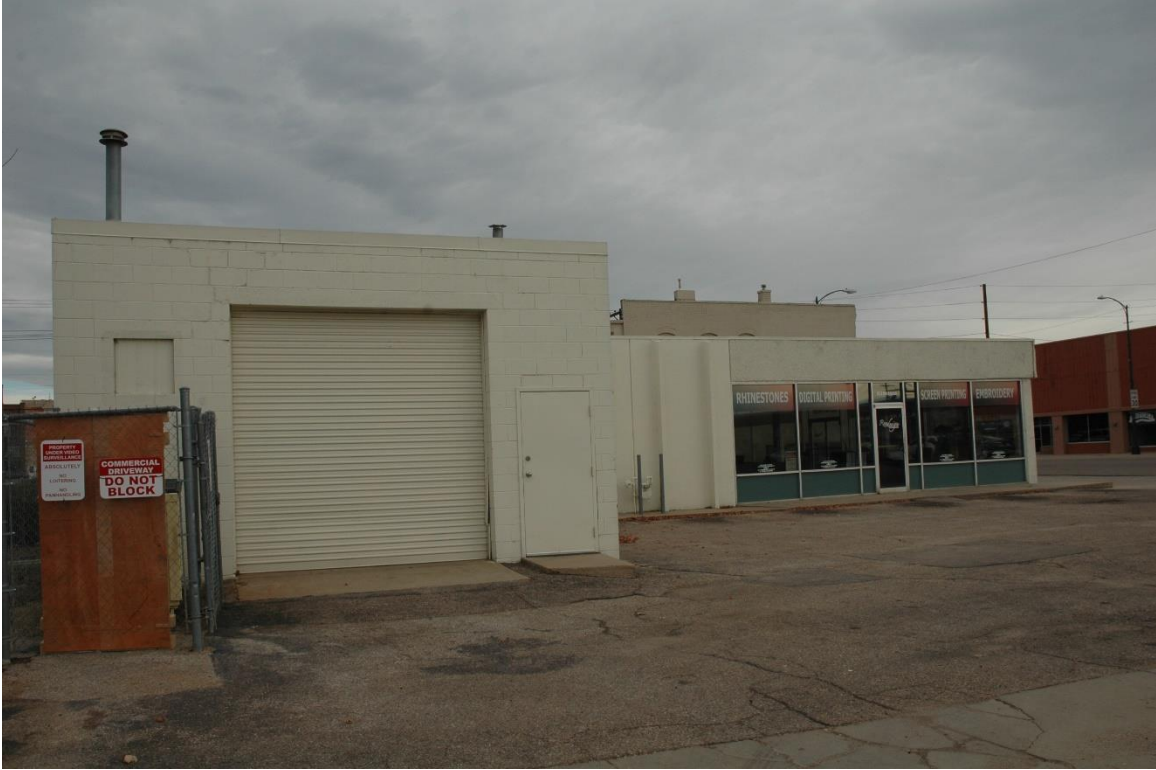
Additions: The attached garage at the west end of the south elevation may be an addition to the original building. It measures 26' N-S by 21' E-W, and features a concrete slab floor, painted cream white concrete block walls, and a flat roof. A painted cream white rollaway garage door, and a single metal door, open toward 11th Street to the south. The garage's east-facing wall contains a glass-in-silver-metal-frame door, with a transom light and a narrow sidelight.

CD 1, Image 12 View to NNE of south side

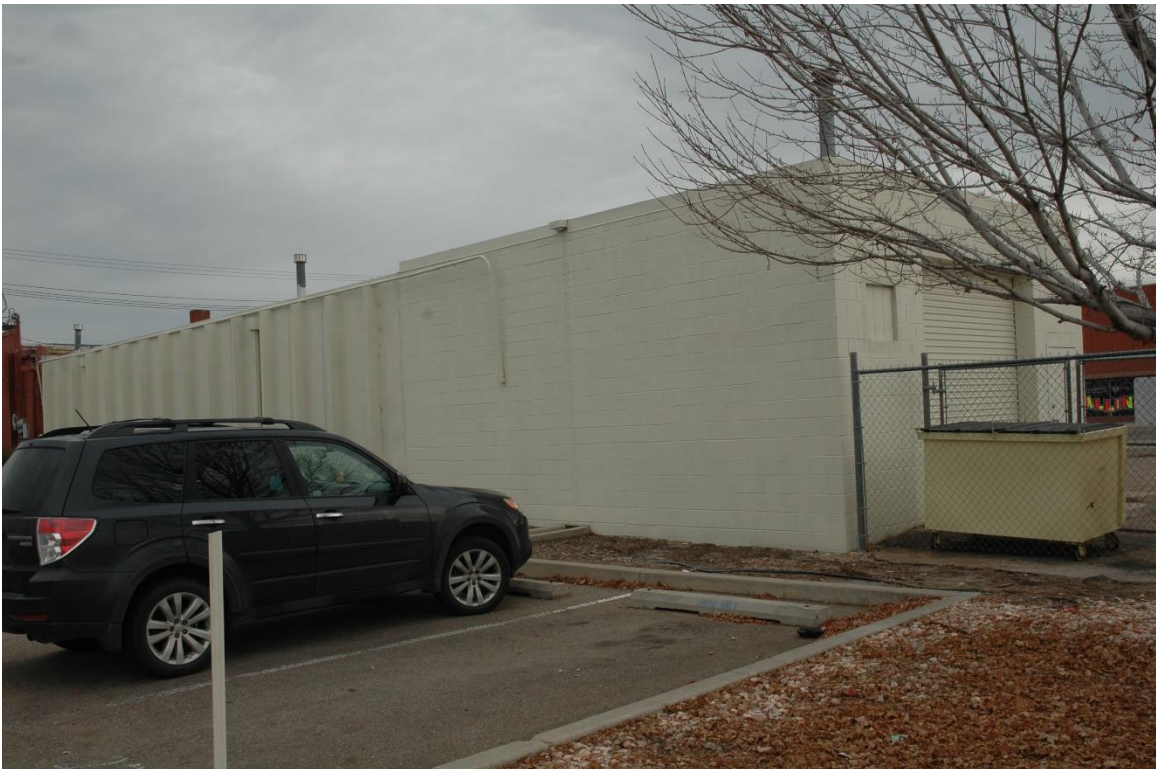
Painted white concrete wall surface above another entry door and display windows. The west-facing (rear) wall, and the western end of the south-facing wall are clad with painted cream white stucco, with decorative buttresses.

CD 1, Image 13, View to NE of rear (west)
