# COLORADO CULTURAL RESOURCES INVENTORY

## Greeley 8th Avenue Survey

### Historical and Architectural Reconnaissance Form

4. Street Address: **1113/1115 8th Avenue**
5. Municipality: **Greeley, Colorado**
6. County: **Weld**
7. USGS Quad (7.5'): **Greeley, Colorado** year: **1950** **Photorevised 1980**
8. Parcel Number: **096108203018**
9. Parcel Information: Lot(s): **1** Block: **84** Addition: **Greeley Original Townsite**
10. Acreage: **< 1 (8916 square feet)**
11. PLSS information: Principal Meridian: **6th** Township: **5 North** Range: **65 West**  
**NW¼ NW¼ NE¼, NW¼** of section **8**
12. Location Coordinates: **Zone 13** **526200 mE** **4474461 mN**  
Datum: NAD83

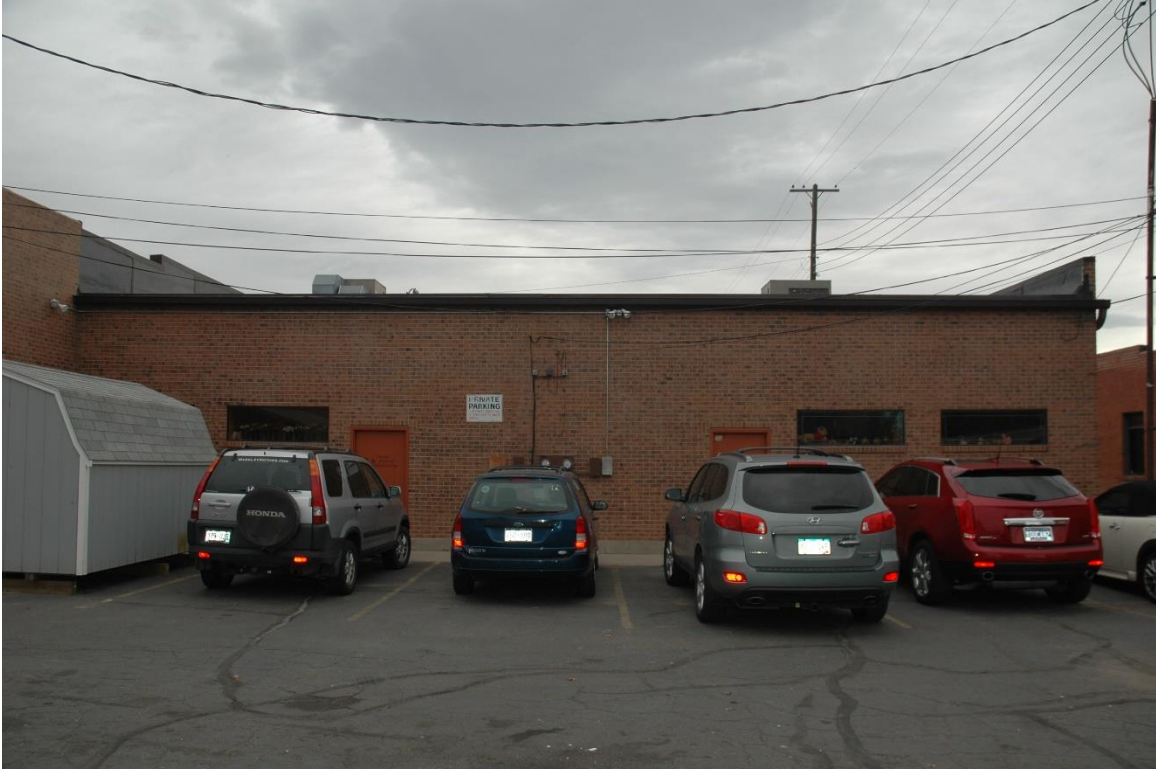
CD 1, Image 24, View to east of rear (west)

Walls: **The east-facing (façade) wall, and the west-facing (rear) wall are made of mottled dark red color face brick laid in running bond. The south-facing wall is made of**

older appearing painted buff red brick laid in common bond. Three non-historic decorative brown metal soffits are affixed to the upper façade wall.

The east-facing (façade) wall contains two sets of large paired single-light fixed-pane windows, with metal frames and red brick rowlock sills and lintels. The south-facing wall contains four small horizontally-oriented single-light fixed-pane windows, with red brick rowlock sills. The west-facing wall contains four somewhat larger horizontally-oriented fixed-pane windows with red brick rowlock sills.

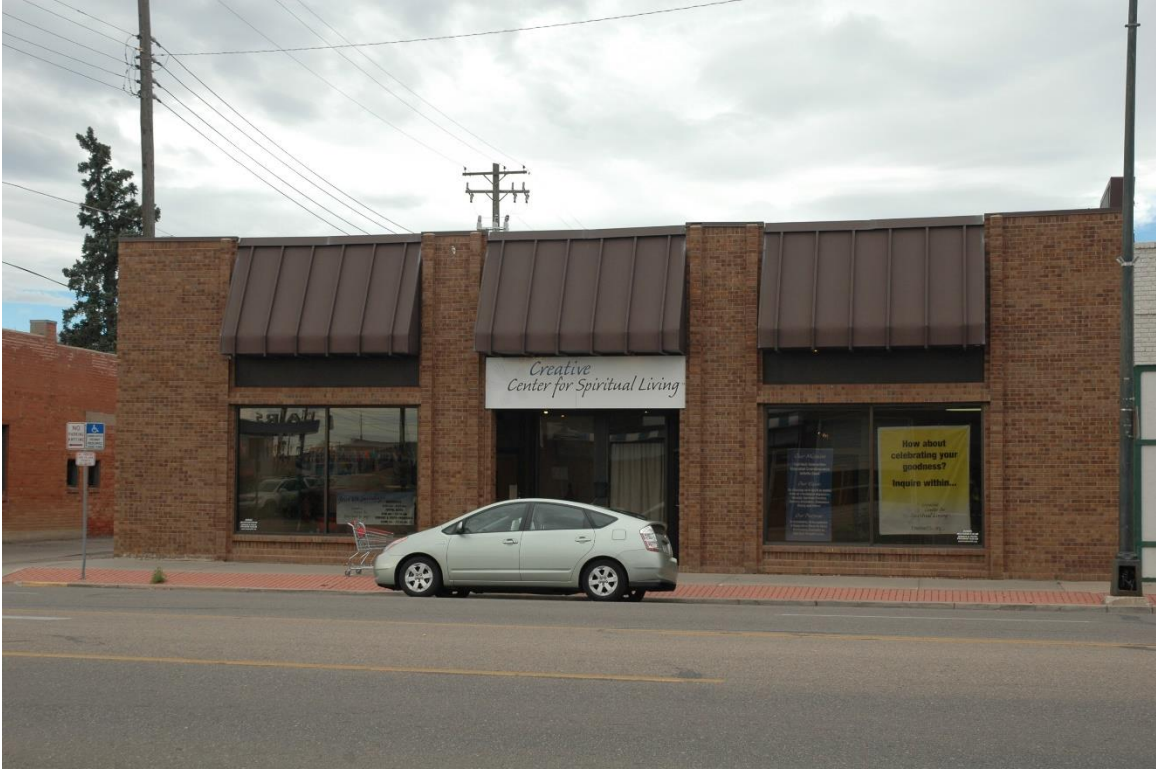
CD 1, Image 26, View to west of façade (east)

The building's symmetrical façade features a centered recessed entryway which contains two angled glass-in-metal-frame doors, with transom lights and sidelights. The entryway and windows on the façade are divided by brick columns.

The building's façade appears to have been significantly altered in recent decades so that limited evidence of the building's historic use as an automobile sales and service garage now remains.

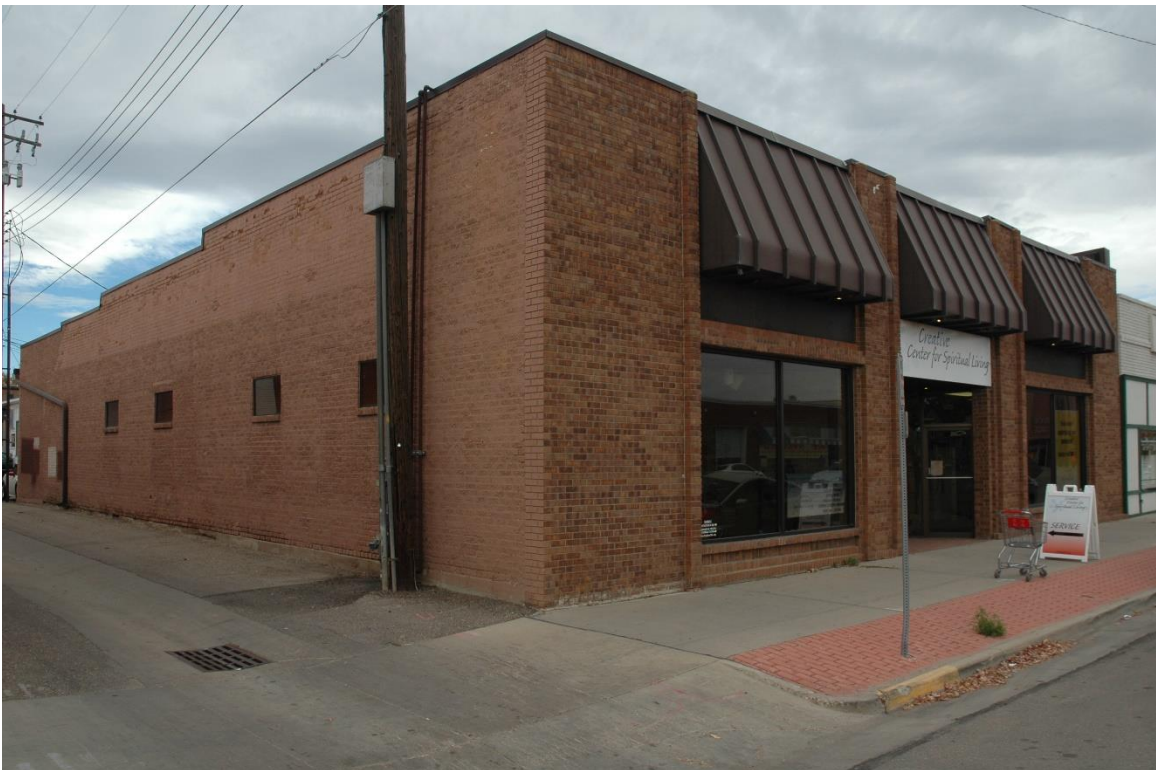
CD 1, Image 27, View to NW of façade (east) and south side

The roof is flat with gravel/tar composition roofing material. A tall flat parapet extends above the roof line on the façade. Tall stepped parapets extend above the roof line on the north and south sides.
